Case Study: Bone Regeneration With NovaBone Dental Putty in a Two Stage Implant Procedure: Histological & Radiological Evaluation

Stephen. A Saroff, D.D.S., M.S.D.
Periodontics & Implantology
Richmond, VA

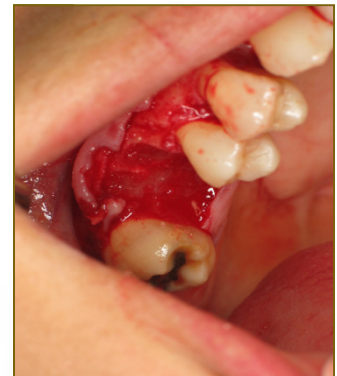
The tooth was extracted atraumatically under local anesthesia. It was determined that the quality of native bone was insufficient for an immediate placement of an implant as seen in figure 1. The lack of buccal plate of bone can also be clearly seen. NovaBone Dental putty was the material of choice to regenerate the bone in the socket. The putty did not require any mixing and was used directly from the package into the defect. No membrane was required since there was enough mucosal tissue to obtain primary closure. The patient was recalled after a week for post operative check-up and suture removal.

Figure 1: Post extraction image of #3

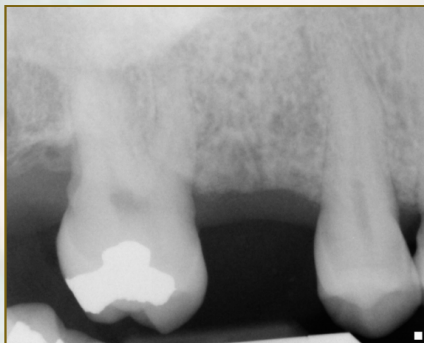
Five months after extraction and bone graft placement, the patient was recalled to evaluate bone regeneration and for implant placement. Radiographic evidence as seen in figure 2 indicated that the bone had completely regenerated and a surgical re-entry was essential to evaluate the ridge. The quality of regenerated bone was also excellent as demonstrated in Figure 3 - healthy natural bleeding bone with a completely regenerated buccal plate.

Figure 2: Radiographic evaluation prior to re-entry

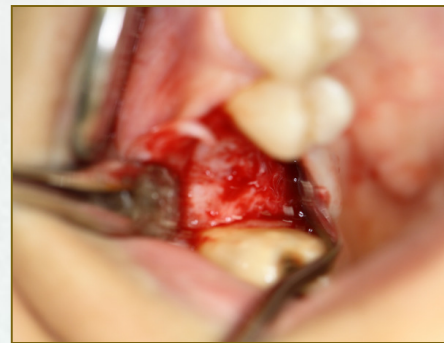
Figure 3: Re-entry demonstrating bleeding bone

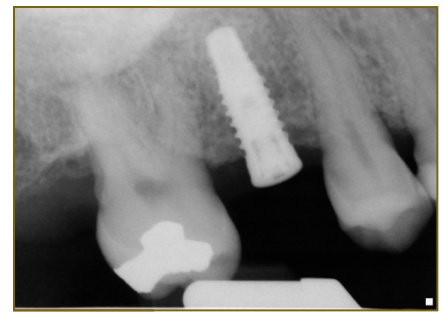
Prior to implant placement, a 2.7mm ID trephine bur was used to obtain the sample core from the regenerated socket. All efforts were made to obtain the core from the center of the regenerated area. The trephine bur with the histology core was then transferred into a container with formaldehyde and sent to University of Connecticut Pathology Department for histological analysis using a H&E stain (decalcified). A Thommen 4 mm x 11 mm implant was placed into the ridge and the mucosa sutured (fig 4).

Figure 4: Post-implant placement radiograph

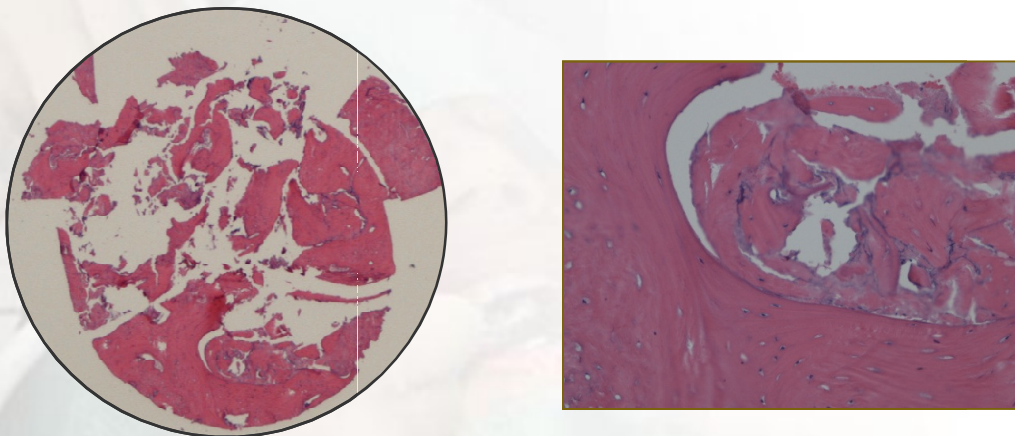
Histology report received from Univ. of Connecticut reveals that the decalcified section contained several fragments of dense vital bone along with thin fragments of osseous tissue and fresh hemorrhagic debris (blood cells). This is indicative of healthy bone tissue as seen in Figure 5. No evidence of putty particles were observed in the histology sections.

Figure 5: Histology core and section demonstrating excellent bone with no evidence of NovaBone Putty

Clinical, radiographic and histological analysis reveals excellent bone regeneration after use of NovaBone Dental Putty. Regeneration of the buccal plate along with an increased ridge width can be seen visually and corroborated histologically. Also, absence of putty particles in the histology sections indicates that putty is completely resorbable and yet regenerates bone simultaneously by a unique phenomenon called '**Osteostimulation**'.
